Future Technology Devices International Ltd TN_161 FT4222H Errata Technical Note

Document Reference No.: FT_001198

Version 1.4

Issue Date: 2020-04-15

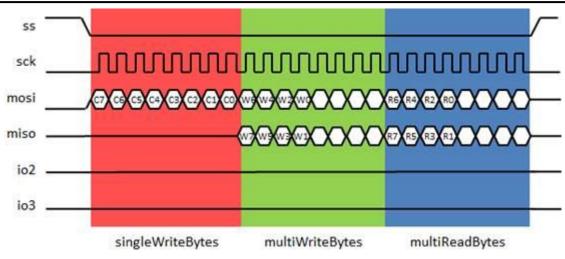
Figure 3.1 Quad SPI with Multi Write Phase

When accessing Toshiba flash with SPI Master Quad mode, FT4222H will hang without giving any responses.

FT4222H operates as master with supporting Dual or Quad SPI with three phases as illustrated in Figure 3.1.

As shown in Figure 1 'C', 'W' and 'R', correspond to "Command Phase", "Write Phase" and "Read Phase", where there are information/data in all three phases that are to be exchanged.

In SPI Master Quad mode, the operation of single write with quad read was not supported. No workaround was provided, this feature is implemented with Revision D.

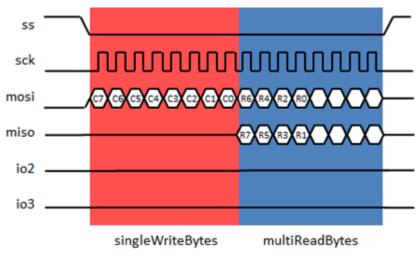
Figure 3.2 Quad SPI without Multi Write Phase

Some flash devices operate with single write and multi read protocol but without the multi write phase as illustrated in Figure 3.2:

Write Phase has no information/data to transfer. This combination of operating mode is not supported with Rev A, B and C.
